Condition Report of the Historic Timbers

Church Farmhouse

Bepton

October 2018

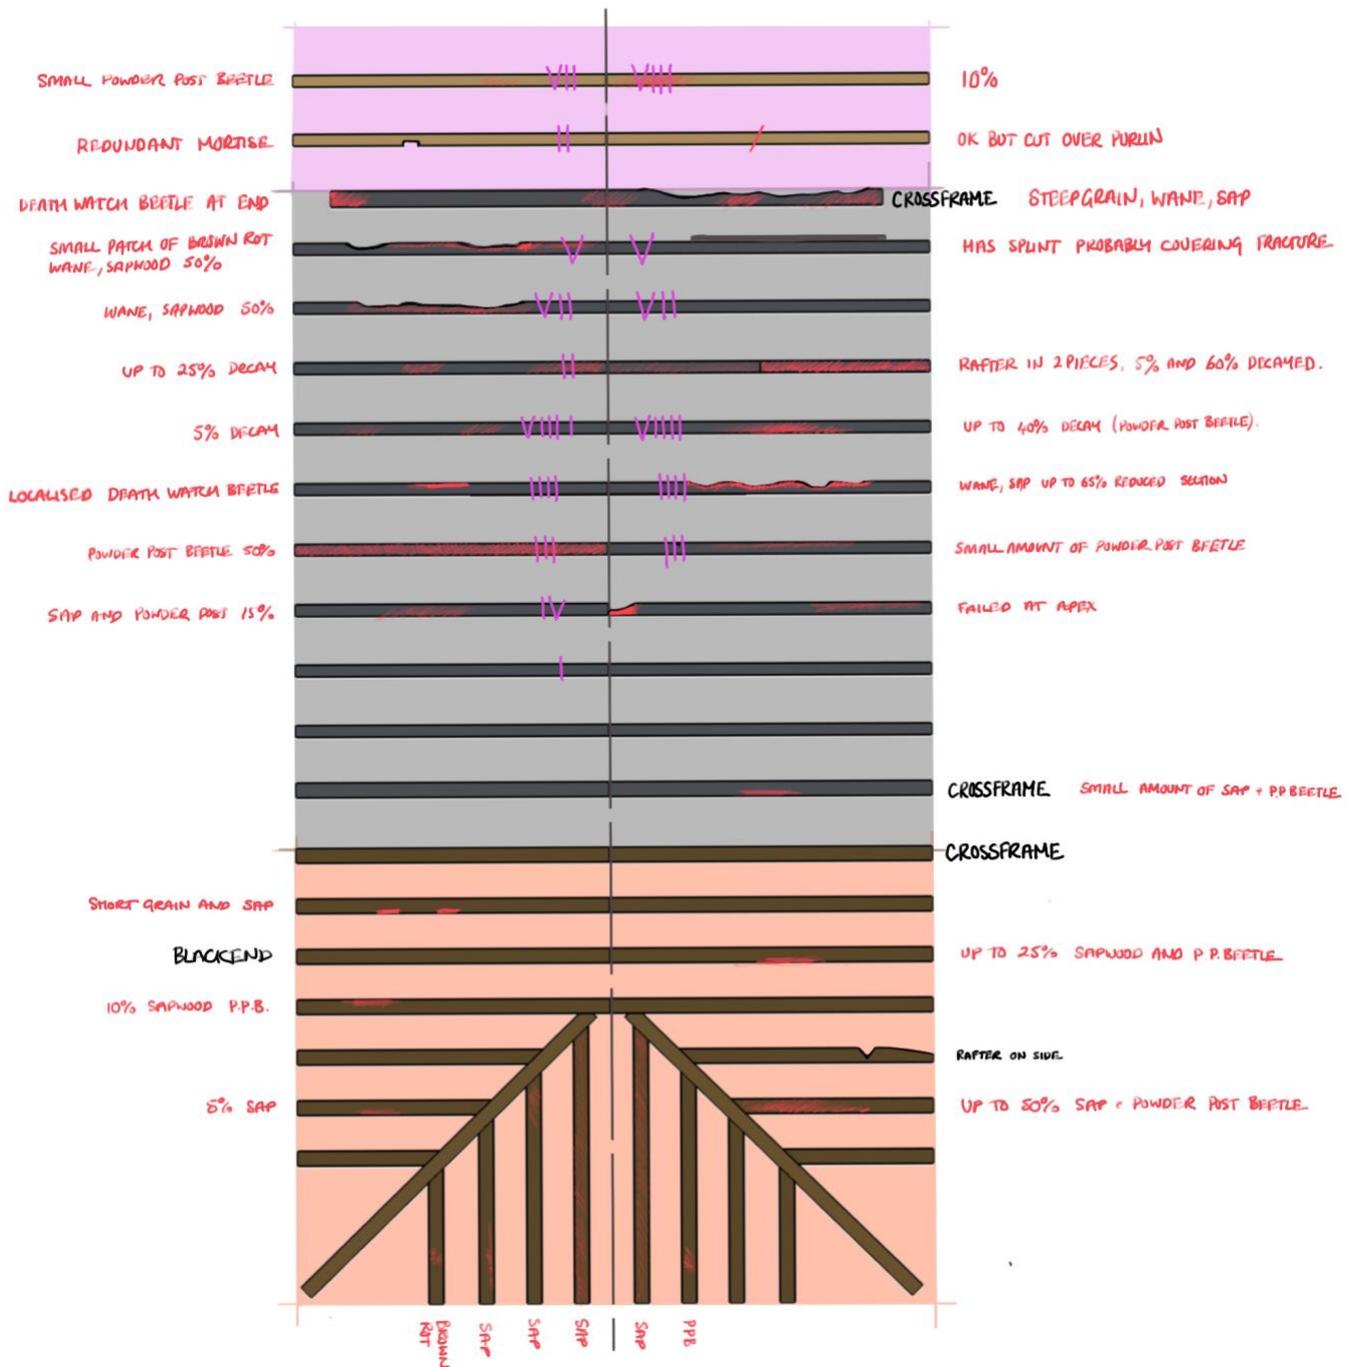
Figure 6, Plan of Rafters.

Generally, Powder Post Beetle was found to be widespread within the roof space, but pockets of both Furniture Beetle and Death Watch beetle were observed. Additionally, there was a couple of very localised pockets of brown rot found.

There is only one timber that causes immediate concern and that is an un-numbered timber paired with an IV where it has decayed at the apex. As the roof space is not a habitable space, we suggest that a triangle of 19mm ply cut to fit the apex and screwed to the side of the rafter pair.

The strength of some timbers has been greatly reduced by the Powder Post Beetle, but, as this damage is likely to have occurred within a few years of the timber being put into service, which was many centuries ago, we can assume that in the current arrangement and loadings the timbers are adequate.

One rafter has a 'splint' fixed to the side. This splint may have been applied to carry the ends of battens, but it is likely that it was applied because of an apparent concern for the integrity of the rafter. This should be investigated, and an appropriate remedy devised and applied.

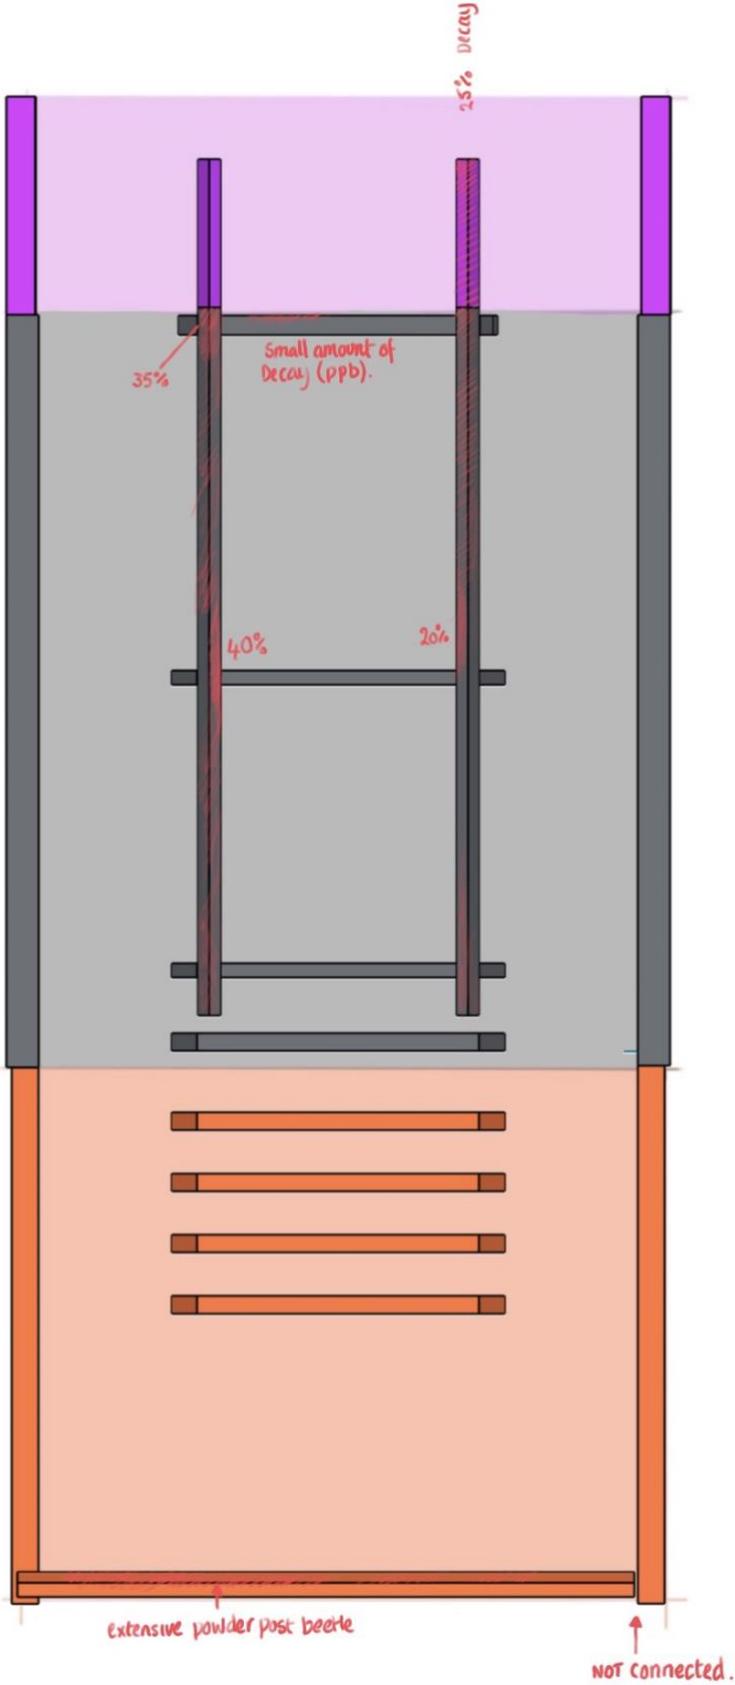
Figure 7, Plan of Purlins, Collars and Wall-Plates.

There a total of eight collars. Two contained within the cross-frames and the remainder as collars to common rafter pairs. Apart from a very small area of Power Post Beetle on the collar nearest the end chimney all other collars are in good condition.

There are two small scantling purlins. Both have extensive wane, sap and the resultant Powder Post Beetle which has reduced the section size by as much as 40%. However, as with the rafters these timbers have been in service for great many years and have not failed. And as such can be assumed that in their current arrangement are adequate.

It was only possible to view and assess very small portions of these timbers. The only thing of note was that the wall plate/Tie-beam in the hipped end has extensive wane, sap and powder post beetle which has reduced the timbers section and strength significantly, however, as this timber is resting upon a brick wall it is providing a fixing for the rafter feet only there is little stress upon it other than the security of the rafter feet. Additionally, this timber is not connected to the wall plate at its Eastern end. A steel bracket could be made up to re-connect the timbers.

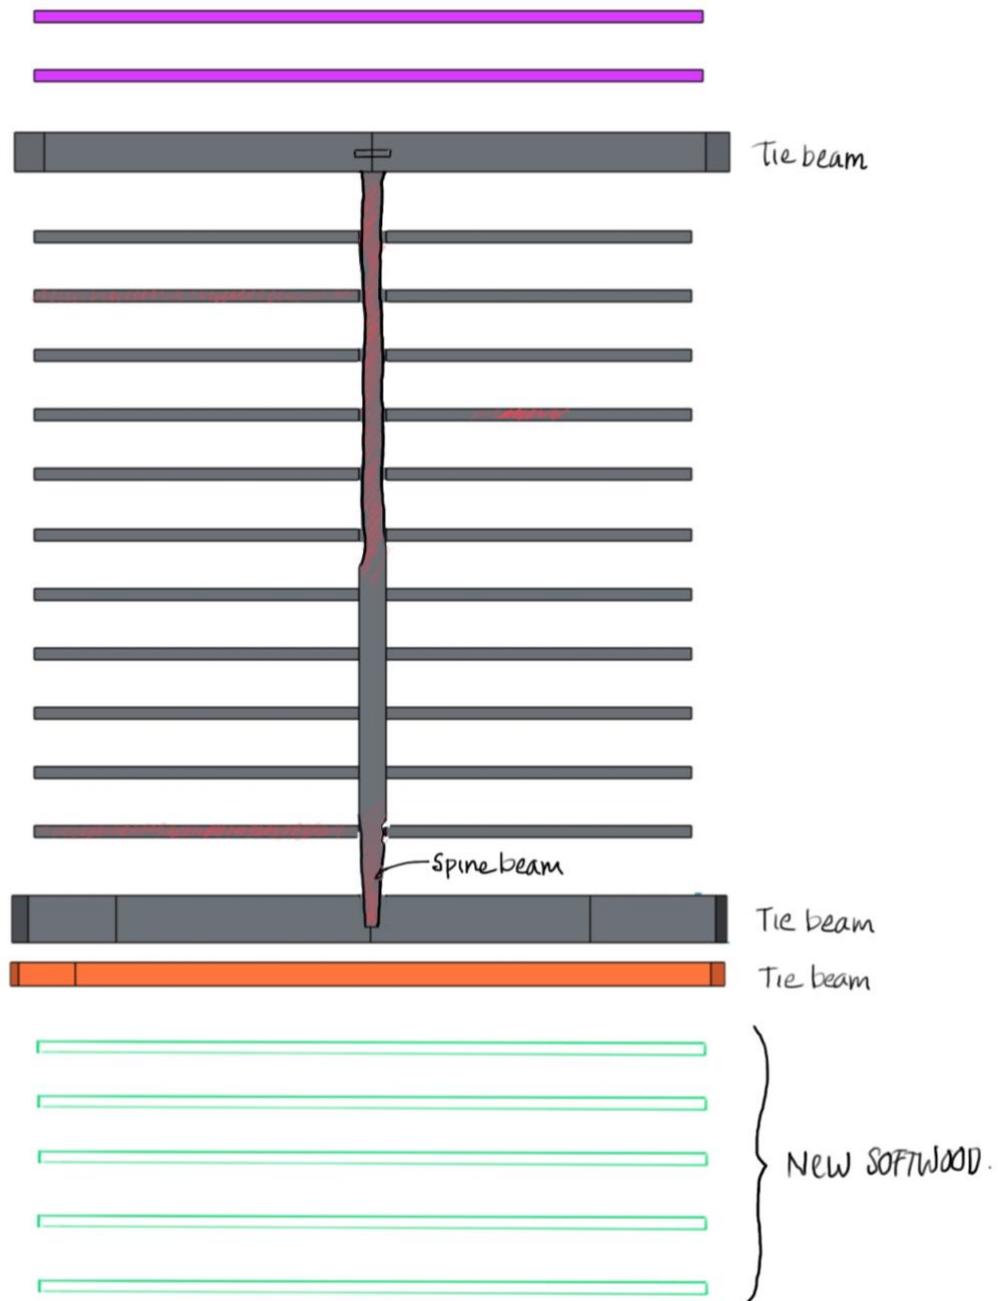
Figure 8, Plan of Joists at First Floor.

Within building 'A' all joists at this level are new tannalised softwood and are not covered by this report. The first-floor ceiling joists within building 'B' are very poor-quality, small scantling timbers with extensive wane, sap and resultant Powder Post Beetle damage. This is also the case with the spine beam which is particularly reduced in section at its connection with the tie beam at its South Western end (B1-B2). These timbers are adequate to carry the loadings imposed by the current ceilings but will not take a floor and it is recommended that when work is carried out in this area crawl boards are used to prevent severe deflection and resultant cracking of plaster ceilings.

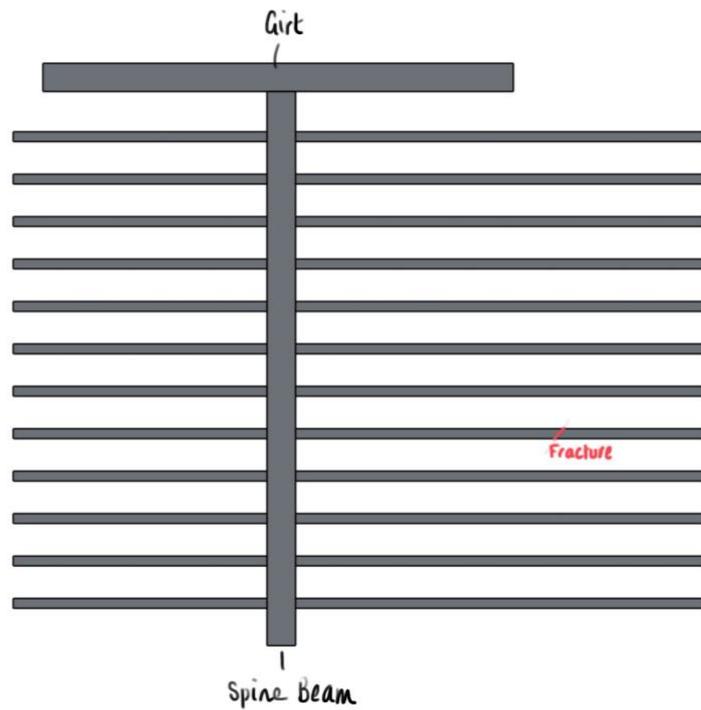
Figure 9, Joists in Frame 'B'.

There is at least one area of concern and that is the 5th joist in from (B-B) which has fractured over the bressummer.

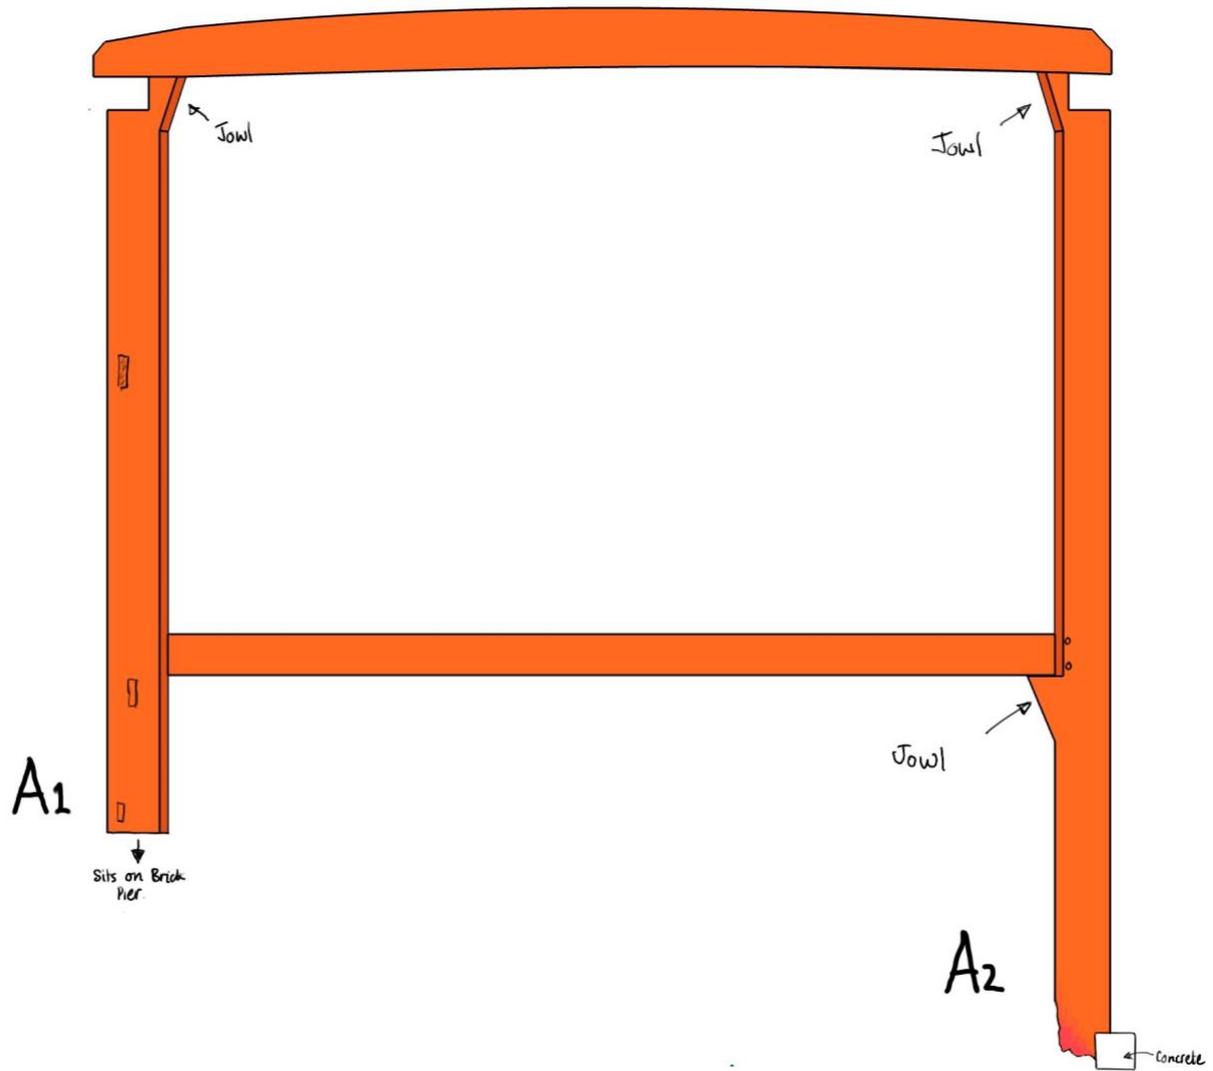
Figure 10, Cross-wall Frame 'A'

Post A1 has been cut and now sits upon a brick pier. Post A2 is decayed at the base with both fungal and beetle infestation, however, the base of this post is covered by a cementitious 'skirting' that may be hiding more decay.

Given that this frame has been underbuilt in concrete block it is unlikely to prove to present a problem, however, as a precaution the concrete should be removed, the base of the post cut level and back to sound timber and brick or other solid surface should be provided at the base.

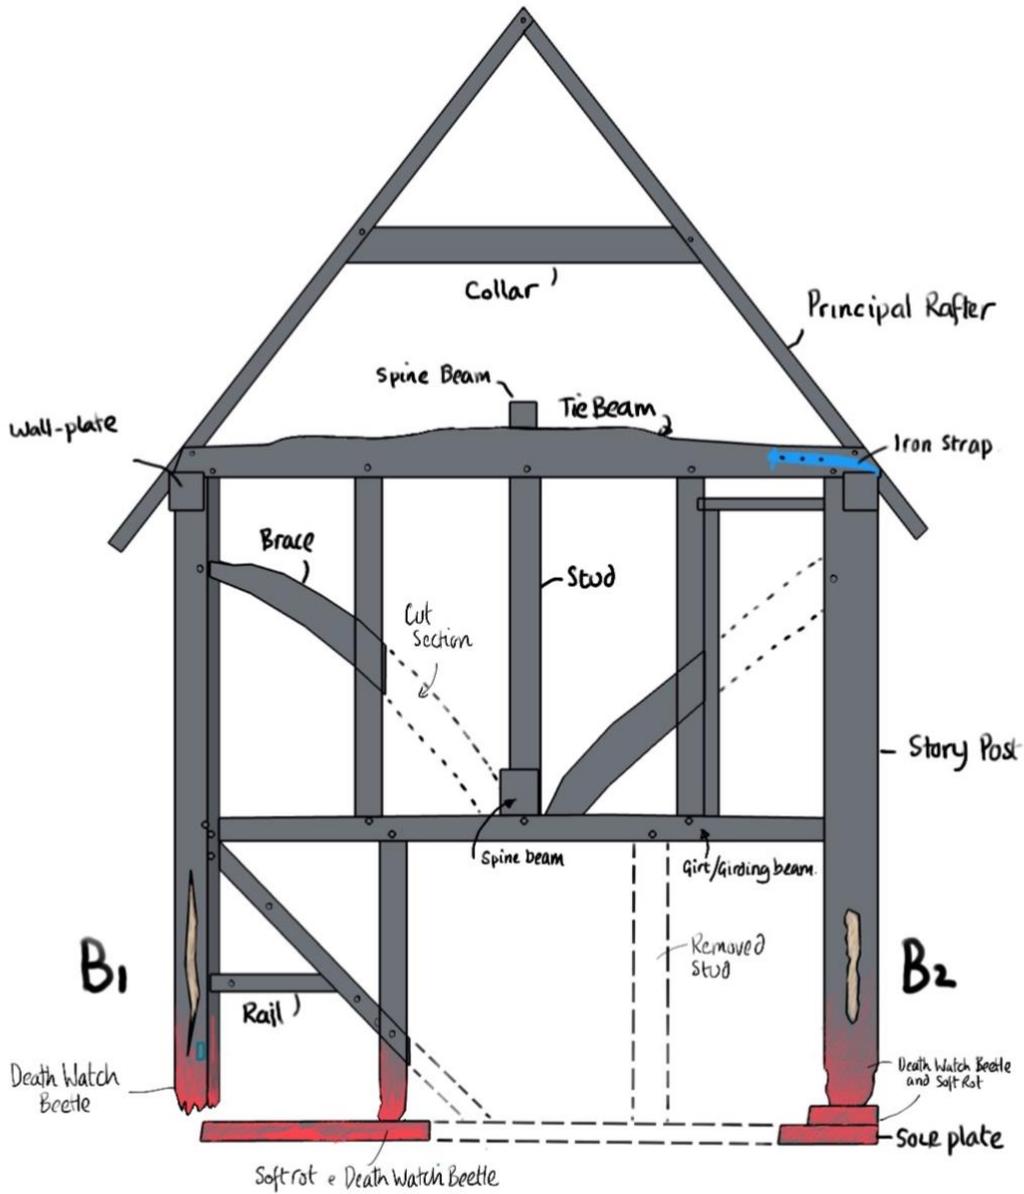
Figure 11, Cross-wall Frame 'B'.

The base of all vertical timbers and the fragments of sole plate suffer from extensive soft rot and Death watch beetle infestation. However, the posts are of such massive section approx. 13 x 13" (325 x 325mm) The same treatment should be provided as for cross-frame 'A'.

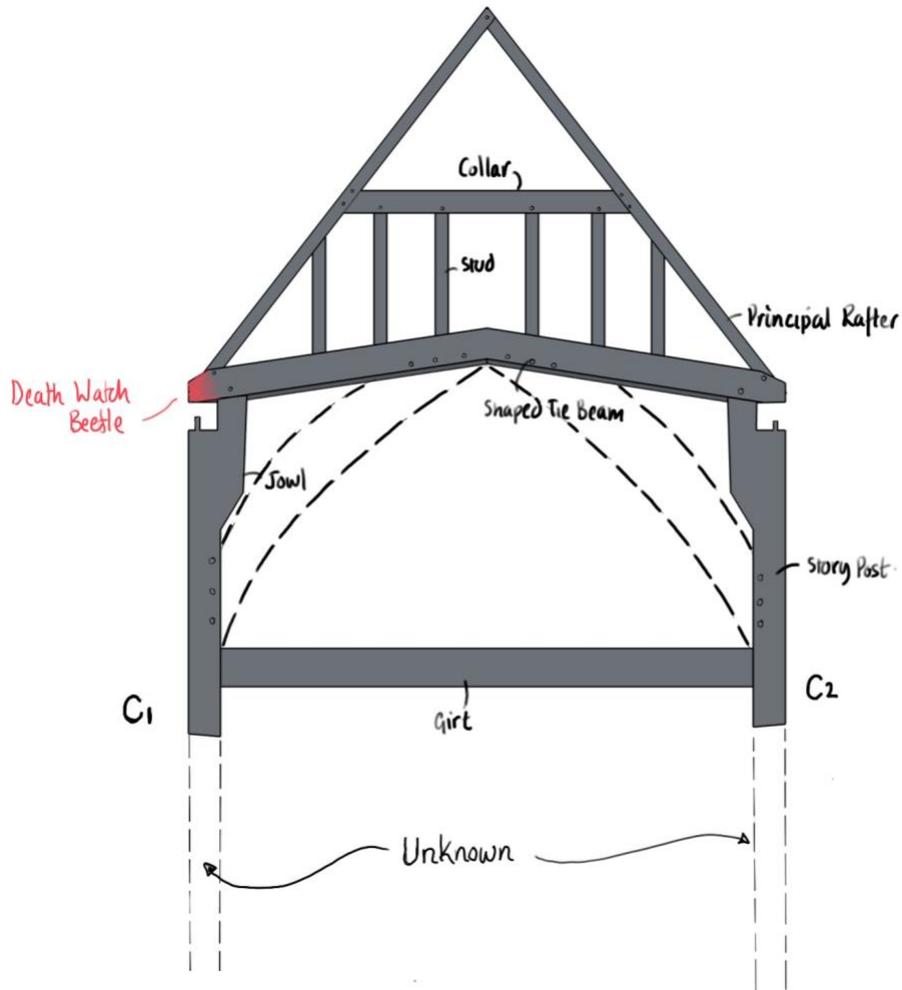
Figure 12, Cross-Wall frame 'C'.

The western end (C1) of the tie beam has suffered historic infestation of Furniture and Death Watch beetle.

As the area is now dry and there are no signs of active beetle, no remedial action is necessary at present. It is not known how much of the story posts (C1 and C2) extend below the girt.
