Condition Report of the Historic Timbers

Church Farmhouse

Bepton

October 2018

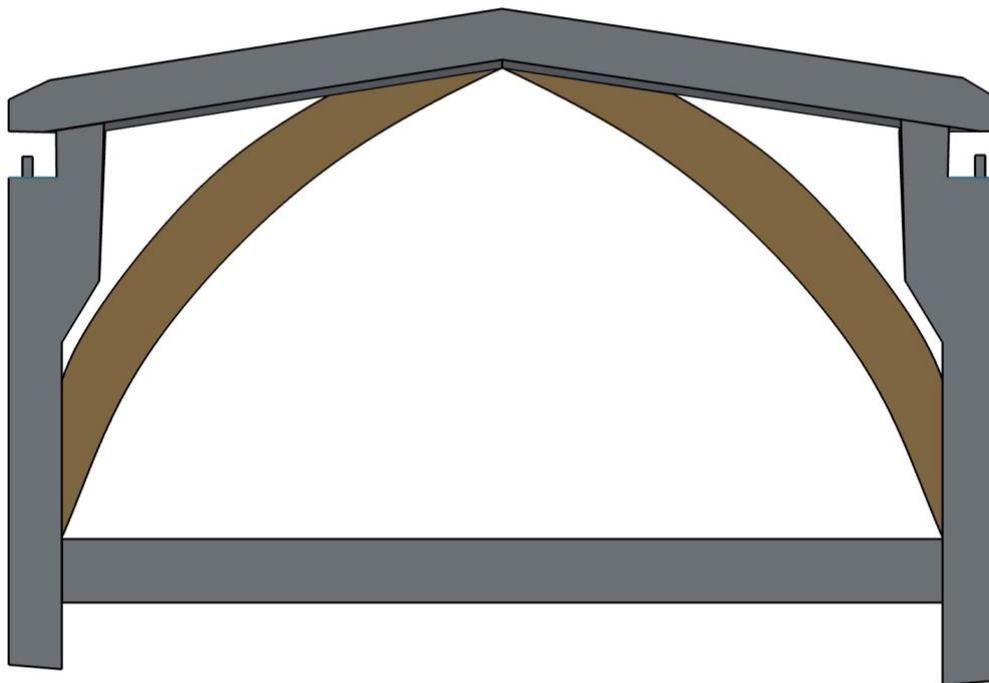
Figure 4, Image indicating how the End Frame (C-C) may have appeared originally (author 2018).

Of the two frames (buildings) Building 'B' is likely to be the later but the higher status and of possible ecclesiastic origin. This is evidenced by the cross frame (C-C), where there is evidence of an arched braced cross frame. Here the tie-beam has been shaped to give a 12-inch (300mm) rise in the middle and braces would have risen up from what is now the floor height to the centre of the soffit of the tie-beam forming an arch. Additionally, there are patches in the inner faces of the jowl which may indicate that there was a spandrel. (for an indication of how this may have looked see below, the timbers indicated in brown are now removed).

All the timbers in this frame are heavily chamfered on the two visible ariss' indicating that all sides where designed to be seen in the original building and thus; a much larger building.
